## DC Water Rapid Repair of Waste Water Treatment Plant Piping System

S. Bian<sup>1</sup> and A.B. Pridmore<sup>2</sup>

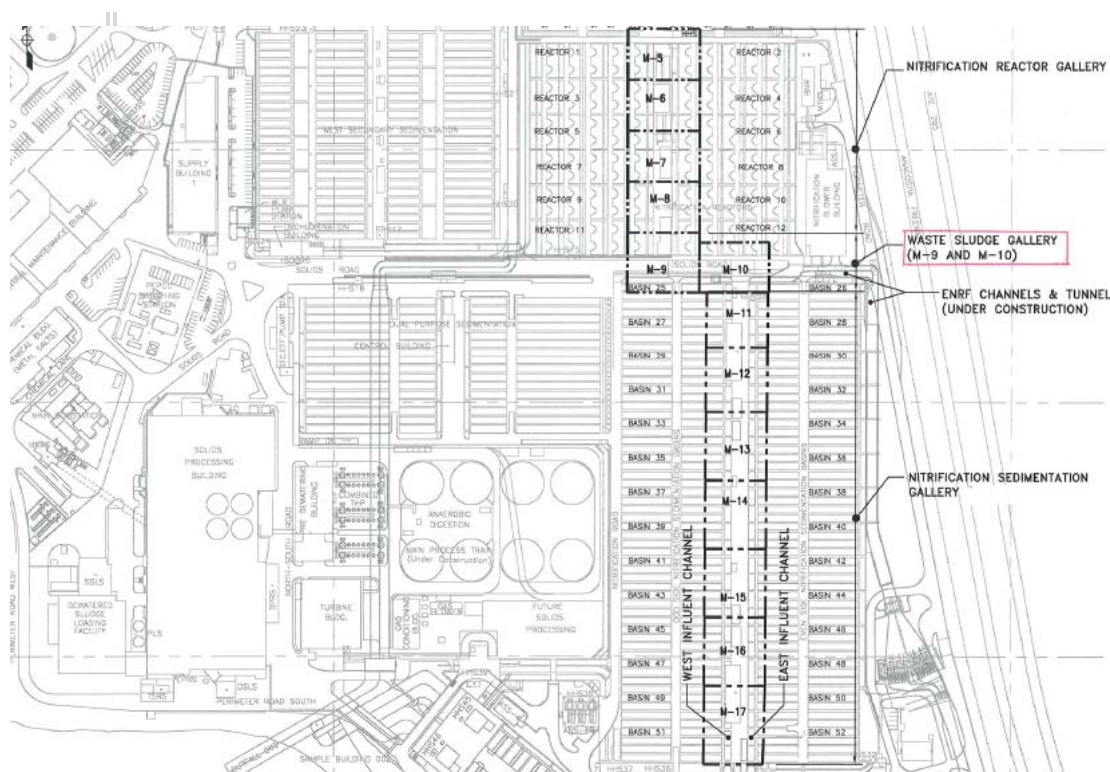
**Figure 3. Plan view of Nit RAS Pipeline**

During a plant upgrade project completed several years ago, deterioration of the Nit RAS pipeline was observed. This was due to abrasion and corrosion, and it was most prominent at the horizontal and vertical bend locations which are shown as regions M-9 and M-10 of Figure 3. Except a few required upsizing of this piping system, no major repairs had been scheduled or executed on these pipelines since they were put in service more than 20 years ago. As a result of the abrasion and corrosion, leaks had developed in several locations along the length of the pipeline.

DC Water originally intended to rehabilitate the entire length of NitRAS pipeline, however the construction schedule requirements did not allow for continuous upgrades during the current outage constraints. Instead, DC Water opted to implement a long-term structural upgrade at the horizontal and vertical bend regions within the pipeline. The bend regions had been identified as areas with more prevalent degradation. In addition, the DC Water decided to inspect the entire length of pipeline while the pipeline was shut down and perform localized temporary repairs in the deteriorated areas identified during the inspection. This approach allowed for the areas with known degradation to be addressed with long term repair solutions and while the inspection and other temporary repairs also allowed for improved planning for future repairs to the pipeline.

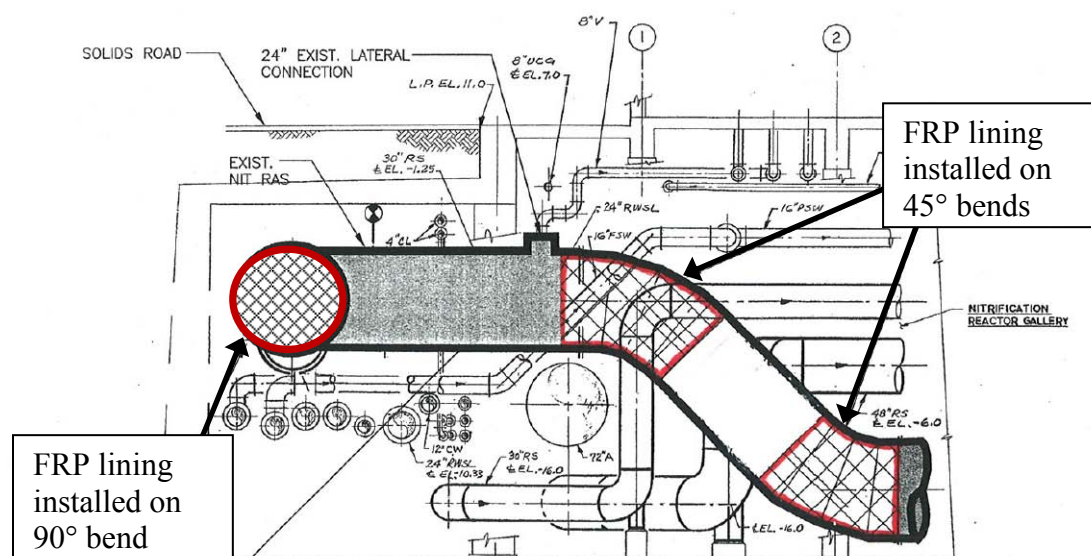
Figure 4. Location of repair

The designated pipeline regions requiring structural repair consisted of two 84-inch 45° vertical bends and two 84-inch 90° horizontal bends on both the West and East side pipelines, for a total of eight regions. The pipeline segments in need of repair were located approximately 25 feet below grade, within the waste sludge gallery, with part of the scope several feet above the gallery floor and part of the scope suspended from the gallery ceiling as shown in Figure 4. Access for materials and personnel into the pipeline was through existing 20-inch and 30-inch man ways in the pipeline, some of which were only accessible by specially built 20 ft platforms which had to be erected prior to the plant shutdown.

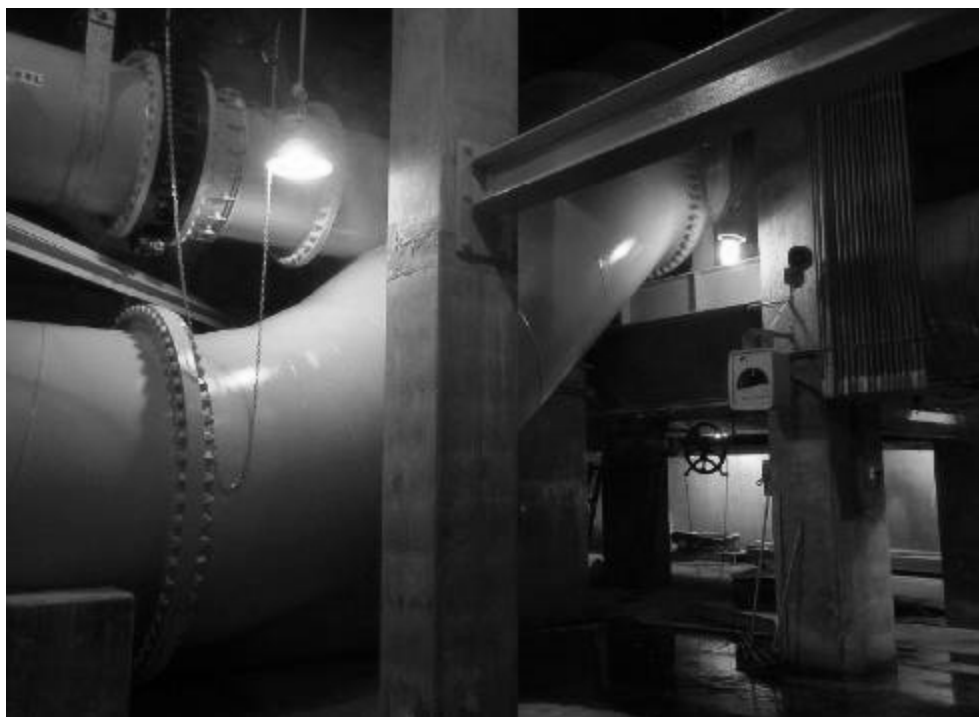
**Figure 5. Outside view of vertical bend regions of Nit RAS pipeline repaired internally with CFRP**

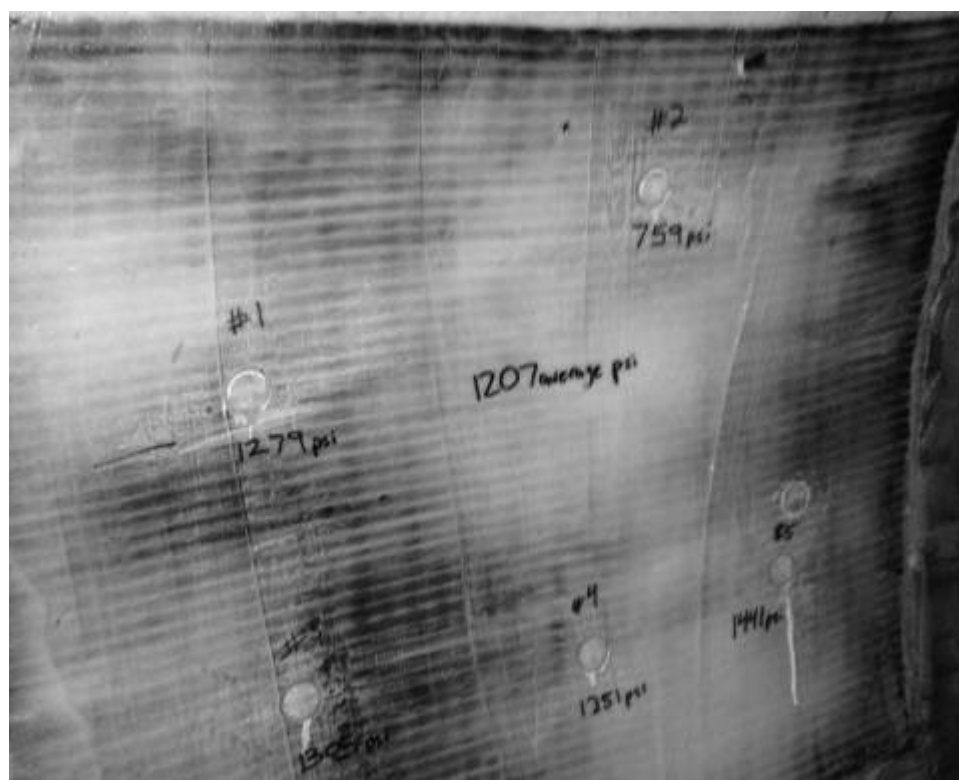
The surface preparation was verified through an adhesion test performed per ASTM D4541 on adjacent substrate. Minimum requirement for the adhesion test value was 300 psi, however values achieved were significantly higher as shown on Figure 6.

**Figure 6. Adhesion test panel with adhesion test results written on the panel**

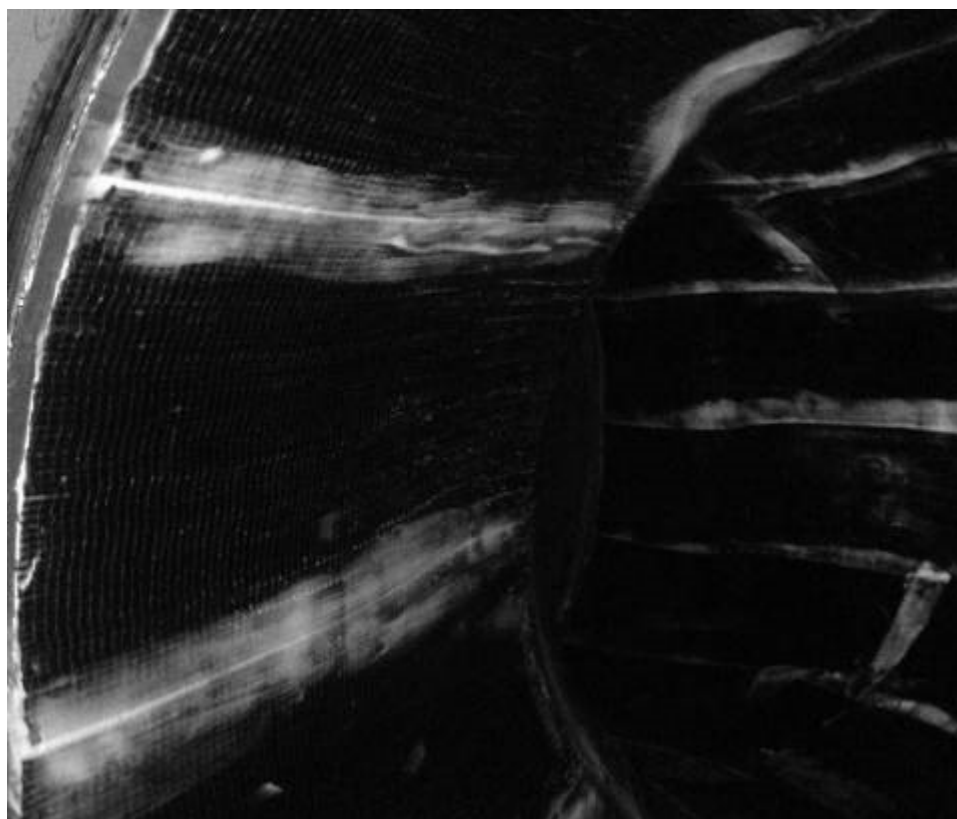
In addition to the 45° vertical bends and the 90° horizontal bends, one of the 90° bends intersected with a 42in lateral and specialized detailing was developed to accommodate this connection as shown in Figure 8.

**Figure 8. Lateral connection repaired with CFRP**

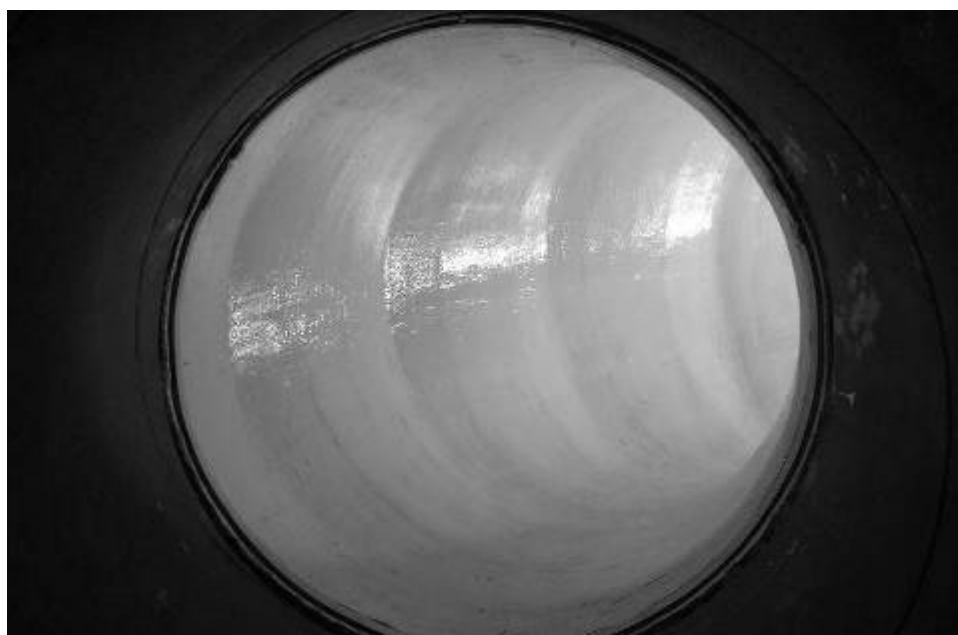
**Figure 9. Completed CFRP lining**

An additional chemical resistant topcoat was applied over the FRP system to provide chemical resistance to the nitrification return activated sludge. The completed CFRP lining system with topcoat installed is shown in Figure 9.
