**SOIL AND
ROCK ANCHORS**

**EXAMPLES
FROM PRACTICE**

VSL INTERNATIONAL LTD.
Berne/Switzerland

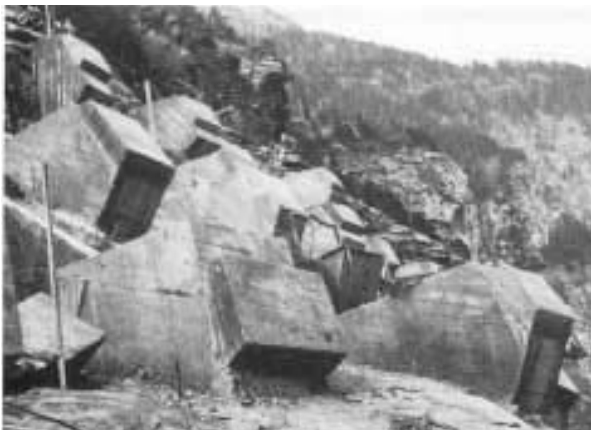
Fig. 6: Anchorage blocks of 1400 kN-anchors

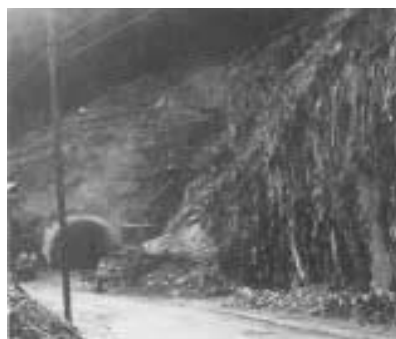
Fig. 8: The site in Autumn 1972 after a slip

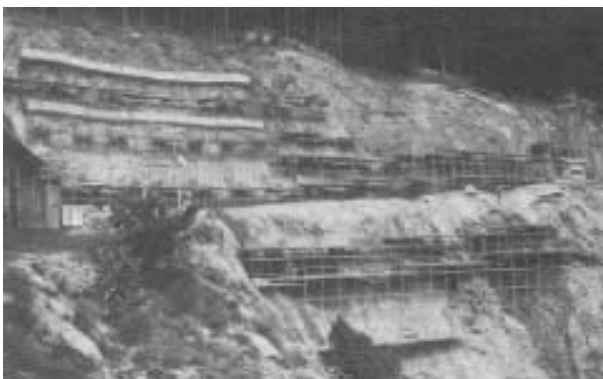
Fig. 12: Overall view of the slope during drilling operations in the middle section

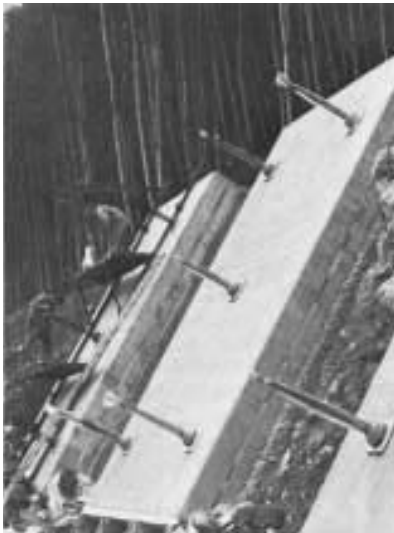
Fig. 24: View of divided retaining wall

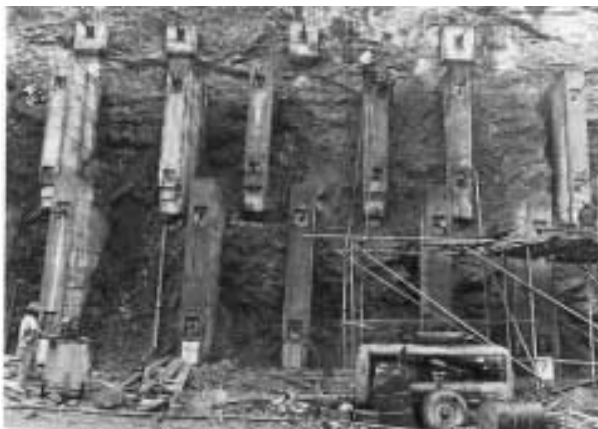
Fig. 27: Anchored concrete tie-beams

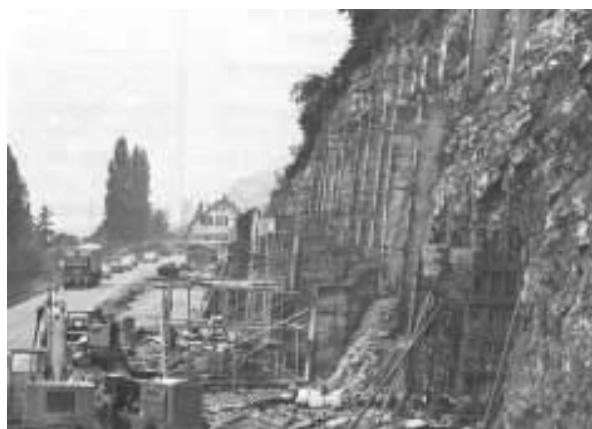
Fig. 29: Construction of staggered wall

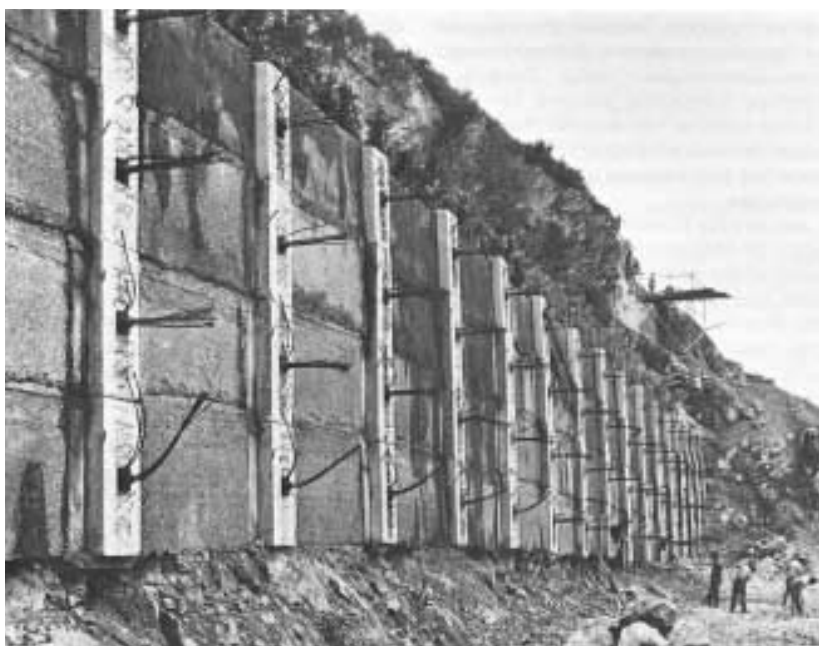
Fig. 31: The wall at Wingreis

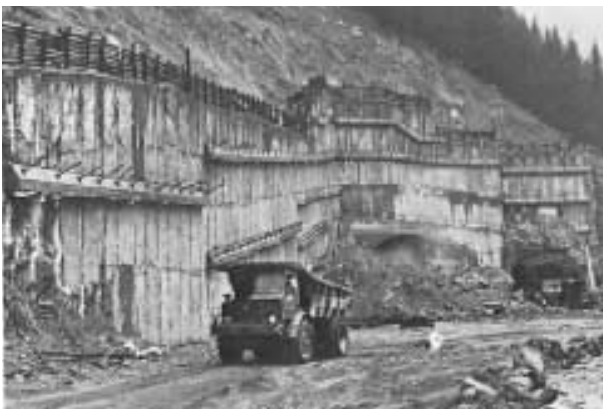
Fig. 33: View of the anchored pile wall

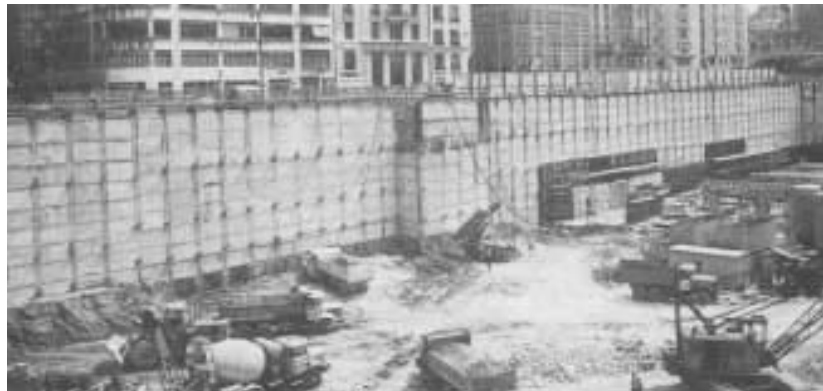
Fig. 39: View of the wall

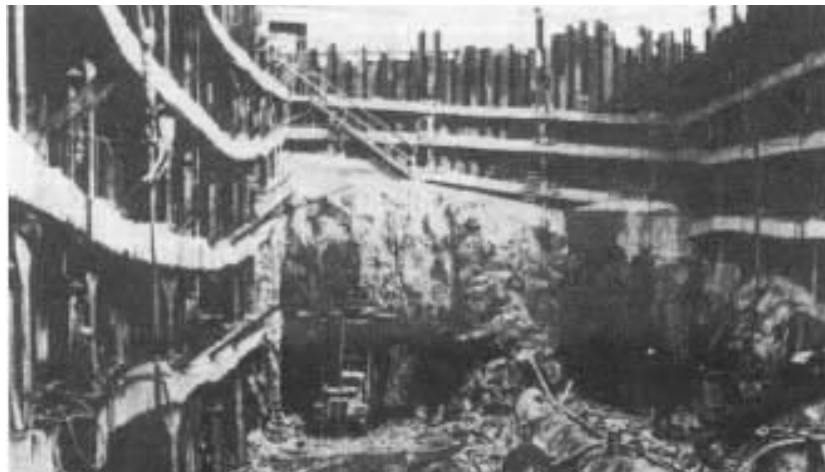
Fig. 46: Geological conditions

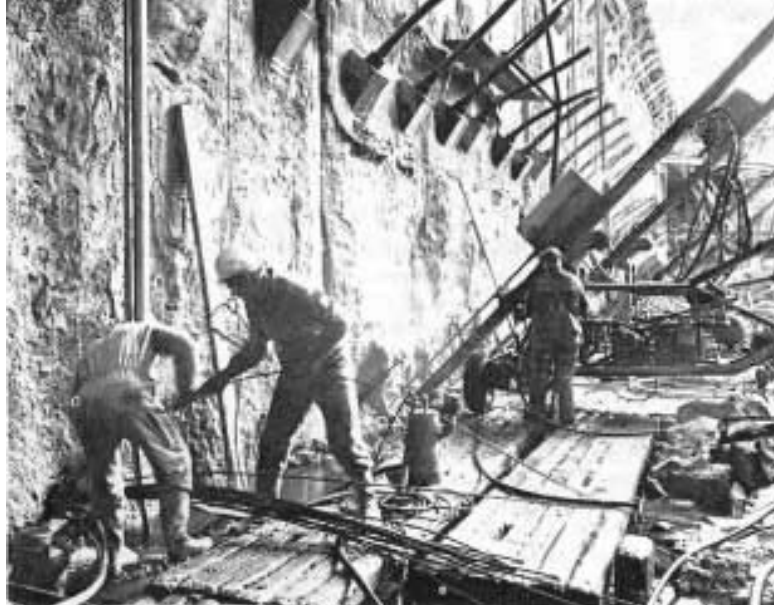
Fig. 48: Execution of the anchor works

The VSL rock anchors used for anchoring the diaphragm wall were of type 5-12, 519 and 5-21 and had a working force of 1,000 to 2,400 kN. Their inclination was

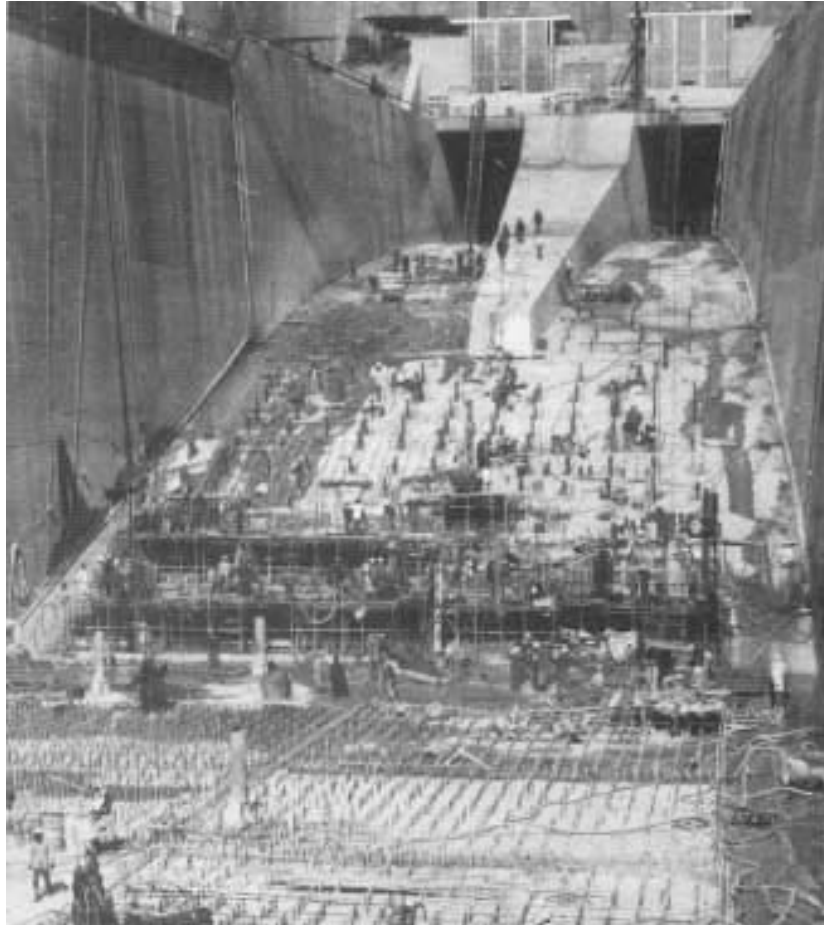
Fig. 57: The stilling basin during anchor work

The anchors were assembled and stored until required on the left side of stilling basin no. 4. Two tower cranes lifted the anchors from the storage area and fed them directly into the boreholes. These cranes were just high enough for placing the 16.80 to 38.10 m long anchors. A sulphate-resisting cement grout with a w/c ratio of 0.42 was used for grouting. Seven days after grouting, the stressing operations in accordance with the FIP recommendations on ground anchors were carried out. After the anchor force had been successfully tested, the protruding strands were cut off two to five days later, the anchors then being completed.

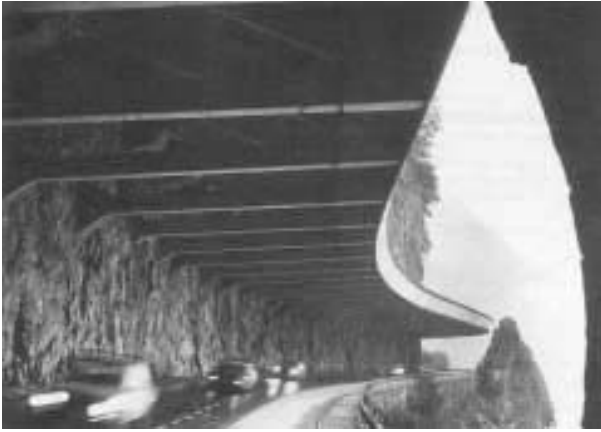
Fig. 71: Partial view of the finished rock fall gallery

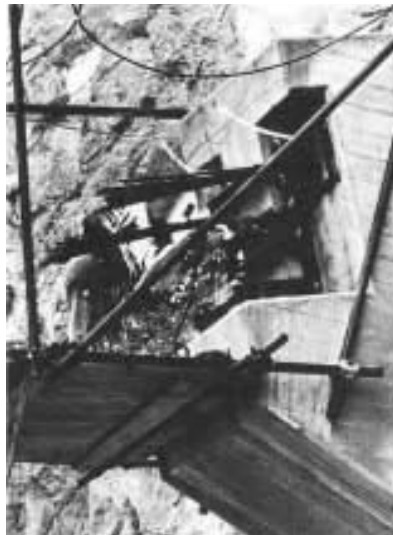
Fig. 73 Anchor work on an upper foundation

and, for the upper foundations, was pressed directly against the rock face by prestressed VSL rock anchors 5-12 of stressing force 1500 kN (see figs. 72, 73). The lower foundations were connected to the rock by dowels constructed from reinforcing steel.

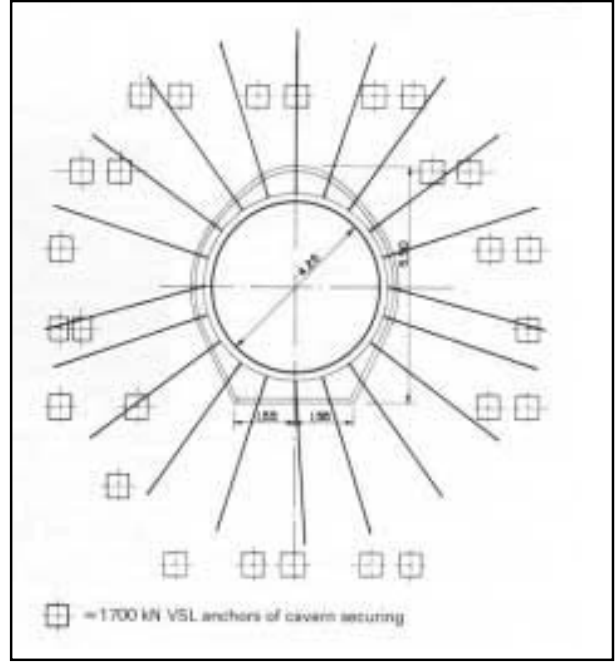
Fig. 75: Elevation

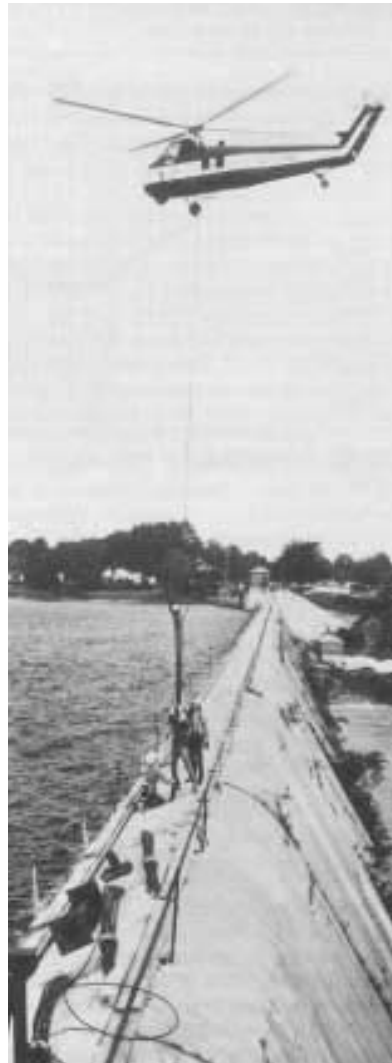
Fig. 83: Positioning of the anchors

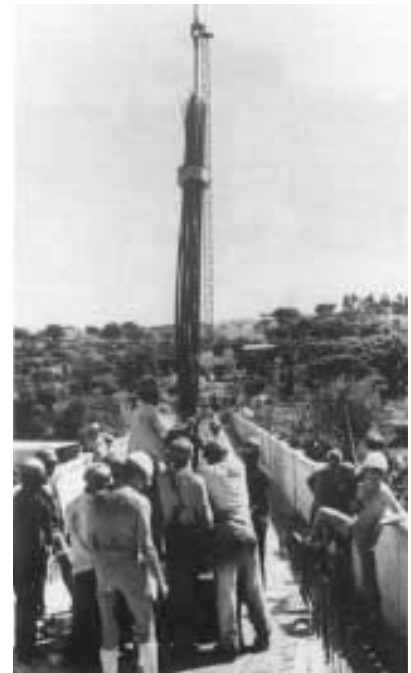
Fig. 85: Anchor installation

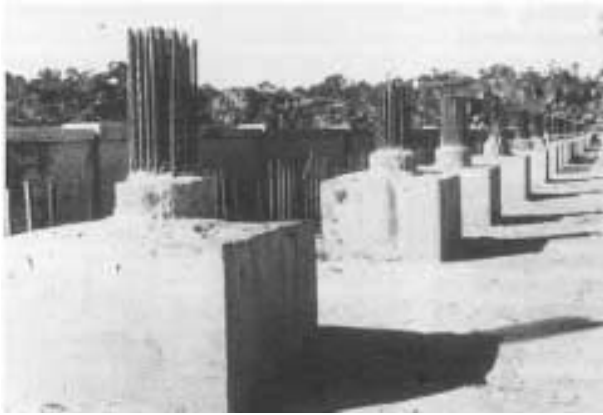
Fig. 87: View of anchor tops

Extensive tests were carried out in order to design grouts which had optimum strength, density, shrinkage and bleed properties. An anchorage grout with a minimum 9-day strength of 25 N/mm² and a maximum bleed of 1 % was used in the bond length of the holes while a second stage protection grout with a minimum 28-day strength of 20 N/mm² and virtually no bleed was used to grout the remainder of the anchor once the stressing operations had been completed.
