# CONCRETE REPAIR BULLETIN

## 2019 ICRI PROJECT OF THE YEAR AWARD WINNER

# Napa Valley Courthouse

NAPA, CALIFORNIA  
SUBMITTED BY PULLMAN

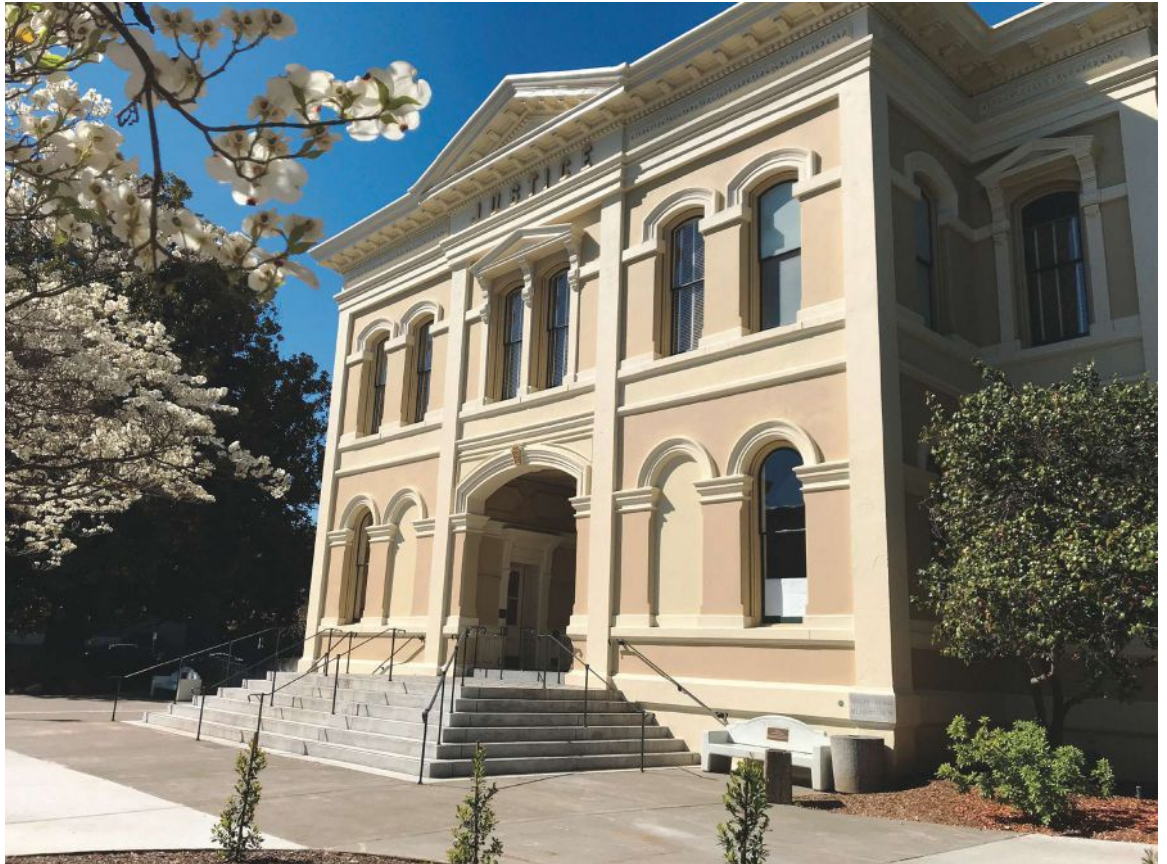
Fig. 1: Napa Valley Courthouse after repairs

Constructed in 1878 in the high Victorian Italianate architectural style, the Napa Valley Courthouse is listed on the National Register of Historic Places (Fig. 1). The 18,000 sf (1,670 m<sup>2</sup>), three-story building consists of a concrete foundation with a full basement, a brick and stucco wall assembly, and a metal roof. The outer walls consist of masonry assemblies covered in Rosendale cement, held in place by iron bands embedded in the foundation. A hipped roof frame is supported by brick walls and timber trusses. The cornice is galvanized iron supported by block modillions. Frieze and dentils wrap the building, along with a simple molding delineating the first and second story. The structure also boasts segmental arched hoods above the wooden windows and double door entrance.

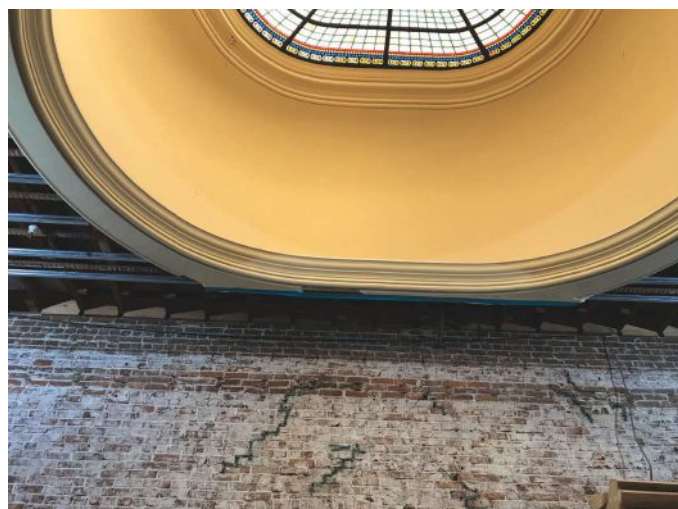
The Courthouse suffered extensive damage after a 6.0 magnitude earthquake struck the region on August 24, 2014. The load bearing masonry walls, plaster, and wood trim exhibited severe damage from the excessive movement (Fig. 2). Shear cracks ran through many of the exterior and interior walls, coupled with diagonal cracking through many of the window spandrels. A gaping hole was visible at the southeast corner roofline, and portions of the interior walls were in danger of collapsing. HVAC, fire sprinklers, and electrical systems were also impacted.

Fig. 2: The unreinforced masonry walls crumbled while the glass from the vaulted glass dome on the second floor was undamaged

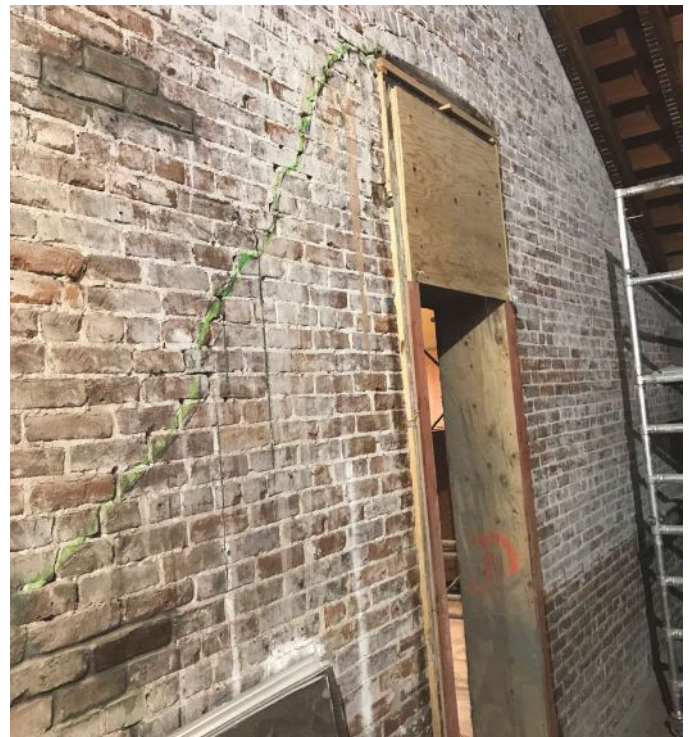
Fig. 3: Traditional masonry repair strategies, including grout injection and masonry ties, stabilized the structure to receive seismic upgrades

The design team's repair strategy enhanced the structure's resiliency by evaluating each structural element for deficiencies (Fig. 3). The seismic retrofit consisted of a multi-pronged approach to address these deficiencies. Because the original masonry was unreinforced, the walls that were completely destabilized needed to be demolished, shored, and rebuilt with grout filled and reinforced concrete blocks (Fig. 4). Load bearing brick walls that did not collapse received externally applied reinforcement. To stabilize walls that were only partially damaged, helical anchors were used to tie various wythes of bricks together.

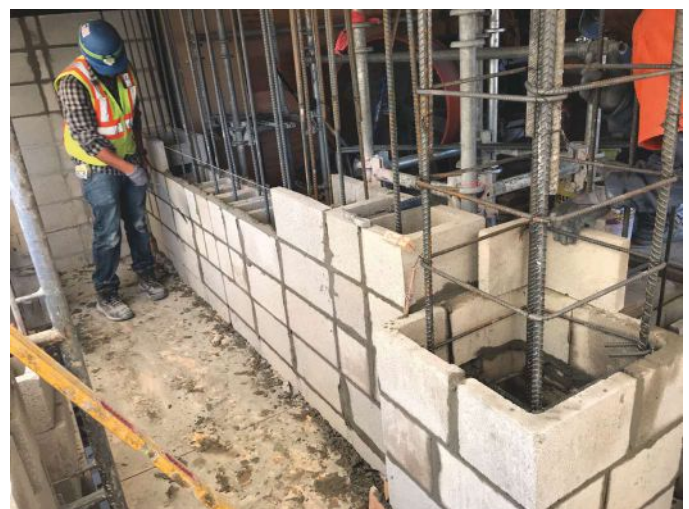
Fig. 4: The versatile building block enabled reconstruction in areas that were completely destabilized

Localized damaged portions of the existing load-bearing masonry walls were rebuilt with existing brick. Walls that were beyond repair were demolished and newly constructed

with grouted concrete masonry unit (CMU) blocks. All new walls were constructed with a specially designed expansion joint system to mimic the thermal expansion properties of

the existing wall assemblies. Over 3,800 ft (1160 m) of crack injection with high strength grout was performed. Twenty-five wall assemblies were rebuilt with CMU blocks and over 300 cy (230 cm) of grout was placed within the blocks.

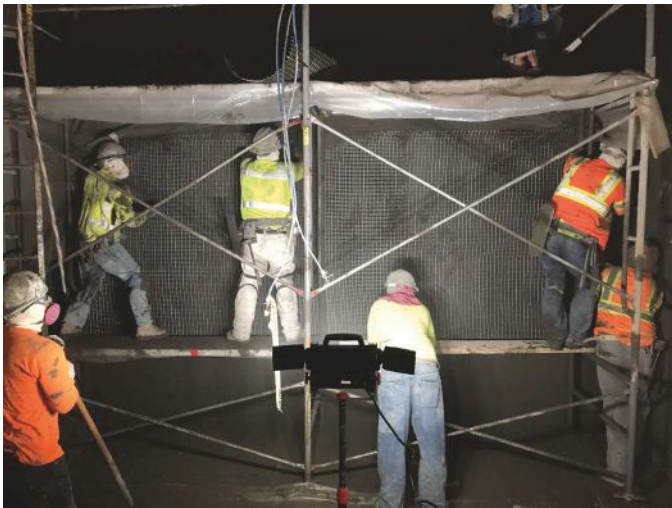
Fig. 5: Reinforcing a wall with the FRCM system

To upgrade the structure for seismic conditions in the event of another earthquake, all unreinforced masonry was repaired using a fabric-reinforced cementitious matrix (FRCM). A new technology in the United States, FRCM is an externally applied composite system which combines a carbon-fiber reinforcing grid into a layer of sprayable high strength mortar (Fig. 5). The application is conceptually similar to traditional enlargements with additional concrete and steel reinforcement, but without adding significant weight or volume. The installation process is faster and requires less preparation than traditional shotcrete repairs. The system also withstands harsh environments and service conditions, including elevated temperatures, humidity, and ultraviolet (UV) light.

To implement the FRCM application, the bricks were brought to the correct moisture content and nominal 1 in (25 mm) thickness for FRCM to properly adhere. Teams sprayed the walls with water and covered them with burlap to retain the moisture two days before applying the FRCM. The FRCM was completely concealed behind new plaster and salvaged wooden wainscot. These steps were taken to accurately reinstall the historical trims. Over 15,000 sf (1395 sm) of FRCM was installed on 43 different wall locations.

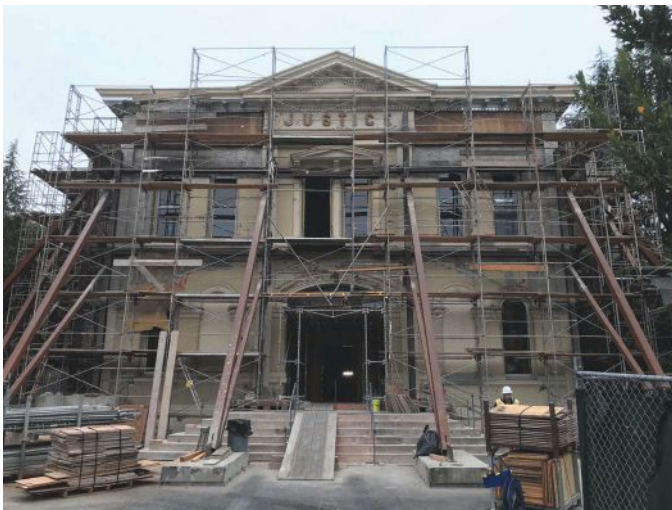
Fig. 6: The Courthouse after removing the sheathing, and prior to exterior plaster and coating work

Refer to Figures 6 and 7 during Courthouse repairs after removing the sheathing and construction near completion.

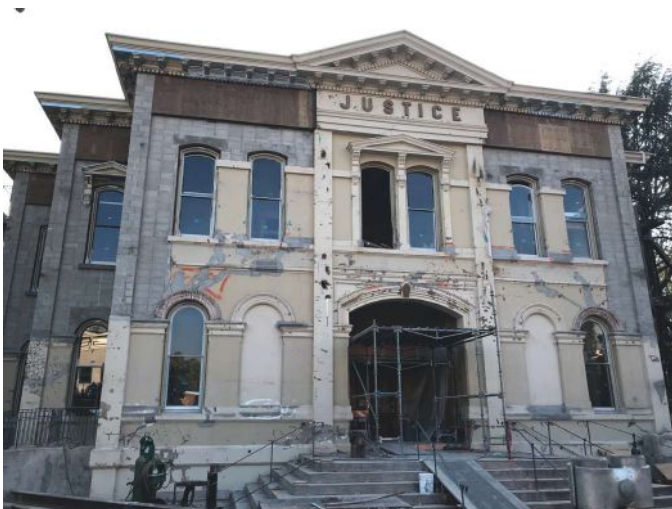
Fig. 7: The Courthouse construction near completion
