## DC Water Rapid Repair of Waste Water Treatment Plant Piping System

S. Bian<sup>1</sup> and A.B. Pridmore<sup>2</sup>

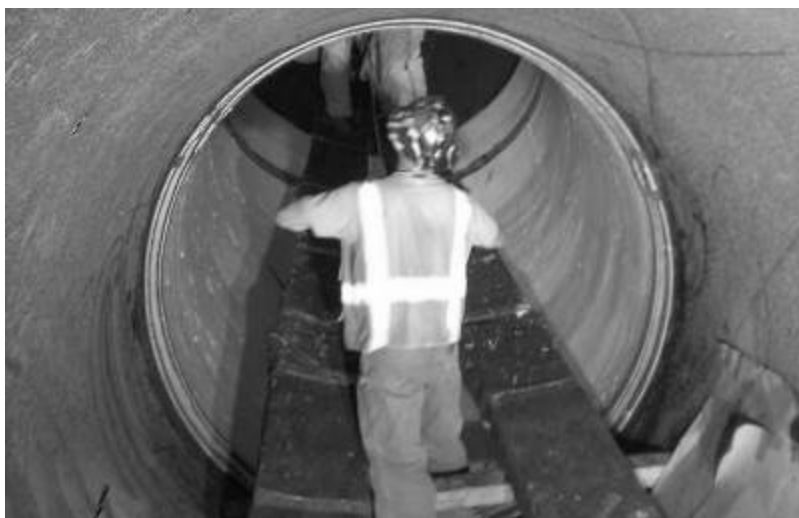
**Figure 7. Access planking system to allow for full circumferential access to the work scope**

In order to ensure complete access to the work scope on the inside of the pipeline, specialty scaffolding was developed so the FRP could be installed without walking on the repair scope and so that the hoop direction reinforcement could be installed in a continuous piece. Figure 7 shows the access scaffolding installed in the pipeline. All scaffold pieces were designed to in order to fit through the existing manholes and then be assembled on the inside of the pipeline to span the full length required.
