Compressor foundation assessment and repairs key to reducing vibrations

Costly problems can be mitigated by optimizing multiple facets related to the foundation. By **Michael Golla**, Structural Technologies

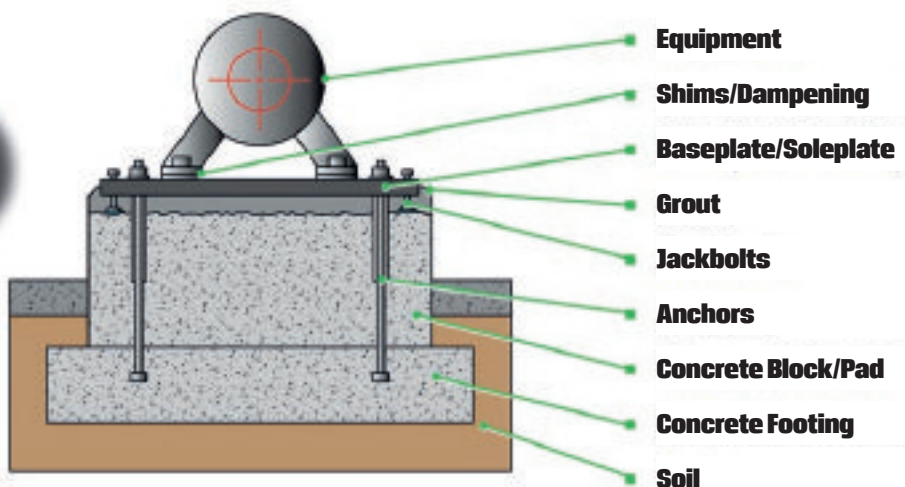
FIGURE 1 Reinforced concrete foundation for compressors

For compressors, a reinforced concrete foundation typically consists of grout, concrete, anchor bolts, jack bolts and soil (see Figure 1). The compressor frame is typically bolted to a baseplate or soleplate attached to the grout and concrete foundation. Jack bolts, chocks or shims might be used at the anchor bolt locations to assist with alignment.

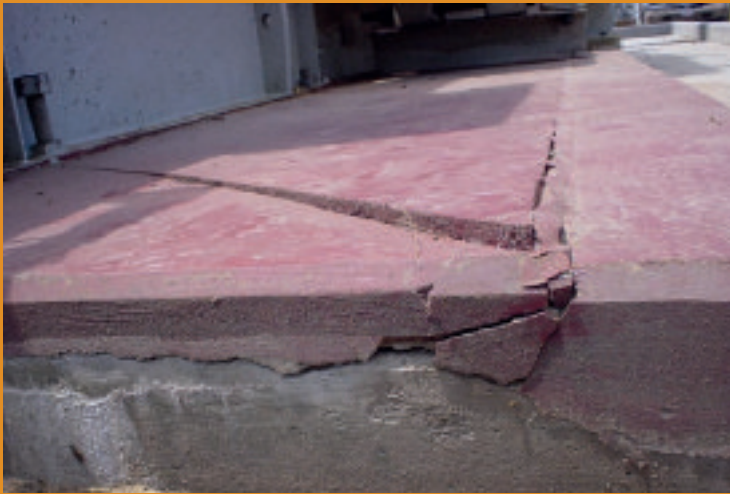
Grout cracking and edge lifting due to excessive grout placement, lack of expansion

the grout design, and grout can separate from the concrete if large grout shoulders are used, causing grout "edge lifting" (see photo #1). Additionally, grout can crack if expansion joints are not used or are not spaced properly. Poor installation can lead to a lack of bonding and voids. Grout should touch the steel above and the concrete below. Steel and concrete surfaces must be prepared properly per guidelines, and grout placement techniques by an experienced contractor must be used to ensure a good bond.

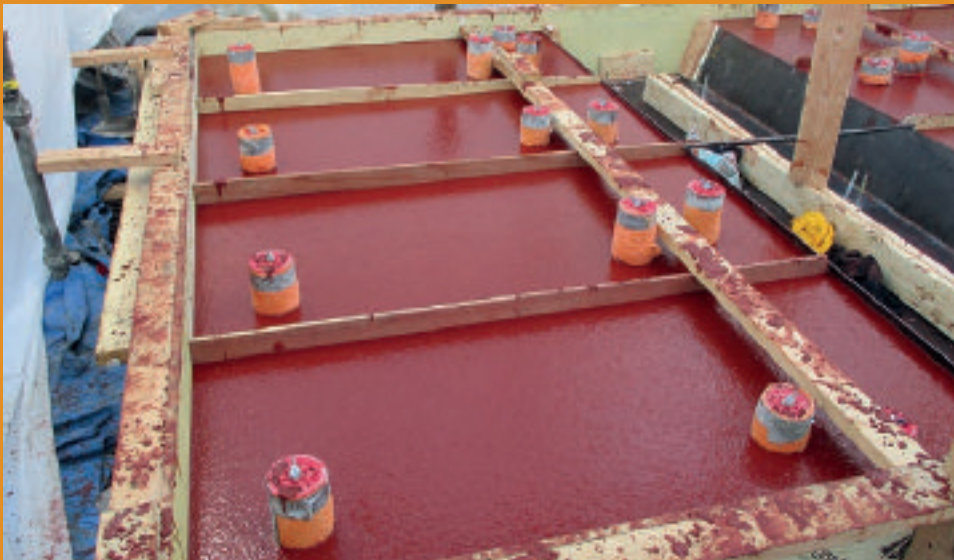
Grout installation with expansion joints and anchor bolt sleeves.

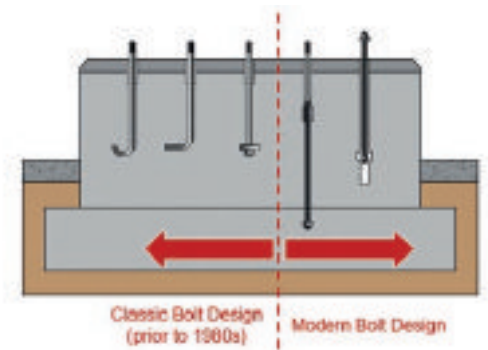
FIGURE 2 Anchor bolt design evolution

Anchor bolts are another critical part of the foundation to resist forces and minimize vibration, and they are just as important as the grout. The grout prevents downward movement and the anchor bolts prevent upward movement. Concrete is strong in compression but weak in tension. Anchor bolts provide the tensile strength. Key considerations include the bolt material and fabrication, the type of termination, tension/torque relationships, allowed stretch, and adequate concrete cover. Many foundations designed prior to the 1980s do not follow today's standards for anchor bolts, potentially causing vibration issues (see Figure 2).

The importance of anchor bolts and termination design has been thoroughly researched in recent years, resulting in new standards for anchor bolt material, thread design and lengths that can also help minimize foundation cracking under stress. For example, "J" and "L" bolt designs, square plates and thin washers used in the past

were not strong enough, resulting in concrete cracking and increased vibration. New designs are much improved. Round plates and plain nuts, instead of square plates and thin washers, help reduce tensile stresses caused by anchor bolts in the concrete. Extra rebar can be installed at the termination point of anchor bolts to provide extra strength and prevent cracking. Additionally, the metallurgy, number, diameter and length of anchor bolts are critical. Undersized anchor bolts were common on older machines. Bolts should now be as long as possible to provide more stretch to increase the clamping force.

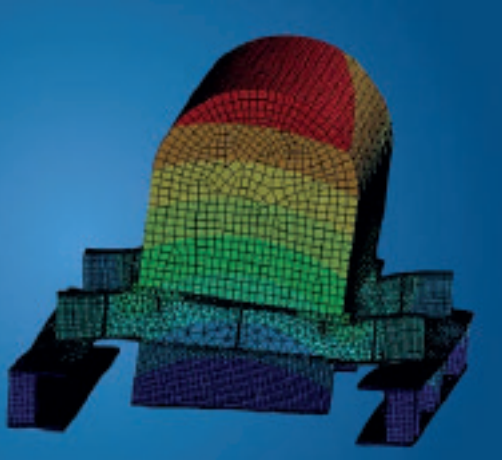
FIGURE 3 ODS example of compressor motor vibration (without animation)

ODS uses sensors to measure vibration at different locations on the foundation system at the compressor operating speed and frequency on a given day. Software is used to provide a 3D animation of the foundation movement (see Figure 3). It might be able to determine if a particular part of the foundation is vibrating excessively, such as a cylinder support pedestal, due to resonance, inadequate design, or deteriorated concrete. It is a proven method for identifying certain types of vibration problems and has been used for many years.

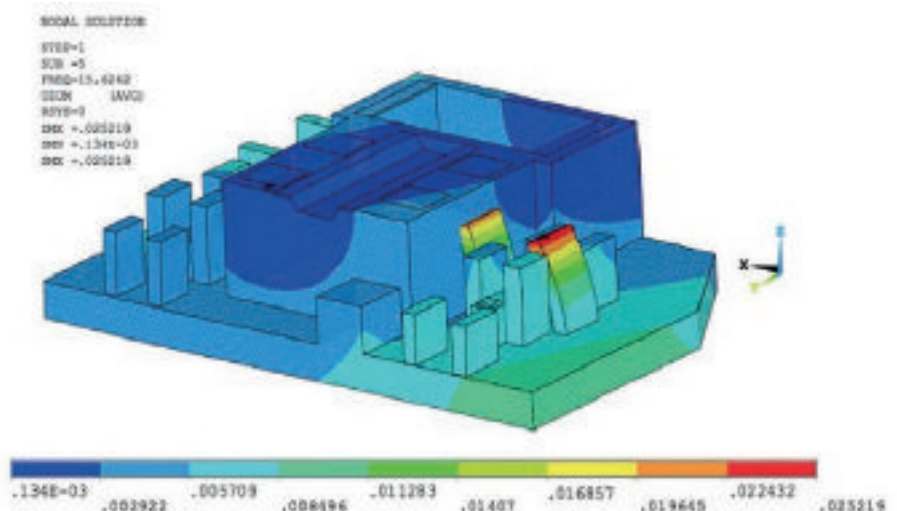
FIGURE 4 FEA results to determine source of foundation vibration

ODS confirmed that two cylinders (one side of compressor concrete block) were moving too much and FEA confirmed that two separate cylinder support piers (not attached to the block) were resonating at compressor operating frequency (see Figure 4) and also contributing to vibration. FEA was then used to redesign the supports to eliminate the resonance. The solution included strengthening and enlarging the pier foundations, connecting them together with traditional rebar and post-tensioned bolts. The foundation block was also rebuilt to remove cracks and restore strength.
